Guide to the Code for Assessment, Repair, and Rehabilitation of Existing Concrete Structures

A Companion to *ACI 562-19*

MNL-3(20)

University of Houston East Garage Fire Emergency Response

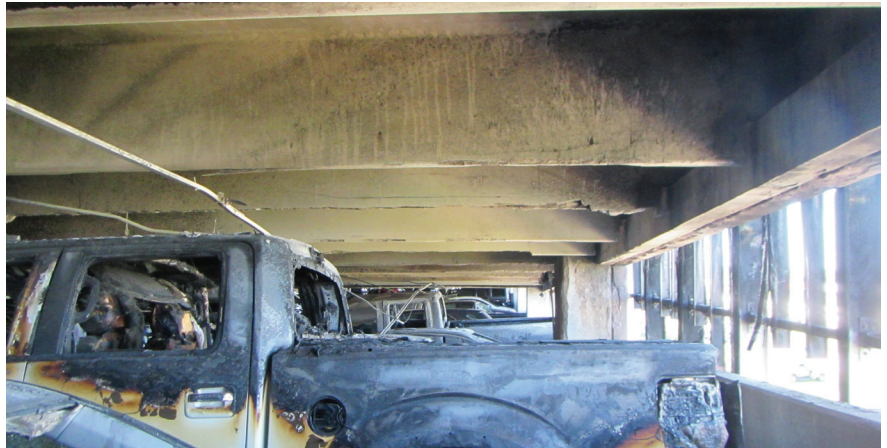
Fig. 2—Fire damage on Level 3 of parking garage

In April 2018, a multiple-vehicle fire occurred on the third level of the four-level University of Houston East Garage (Fig. 2). Significant structural damage occurred to two columns, the framing of the level above, and the exterior signage (Fig. 3). Before a survey of the damage could be completed, shoring was installed as a precaution to prevent the possible collapse of damaged members (Fig. 4).

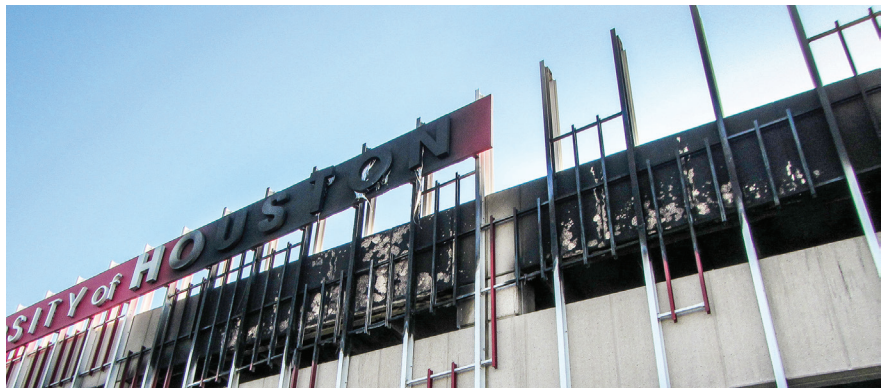
Fig. 3—Fire damage at exterior of garage

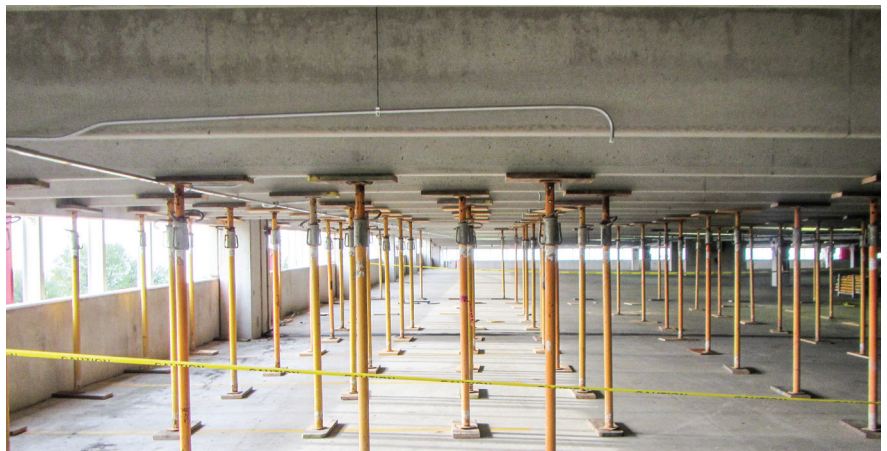
Fig. 4—Shoring installed in affected areas

Emergency shoring addressed the initial safety concerns for assessing the damage and reduce the threat of a possible collapse. With student finals around the corner at the University of Houston, it was understood that the East Garage would need to remain in use on all undamaged levels. This presented another challenge to the construction team: safely making localized repairs to damaged elements with limited intrusion to occupants while considering the safety.

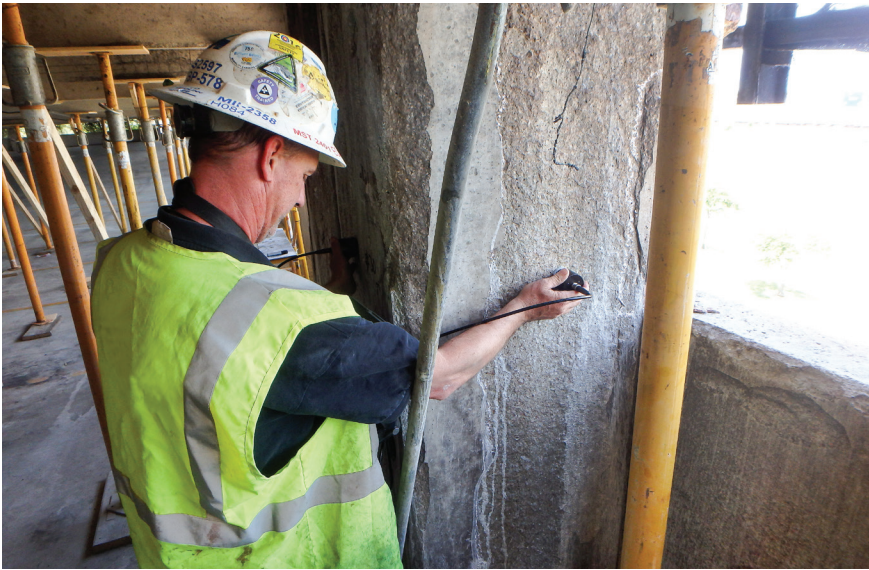
Fig. 5—Nondestructive testing performed at damaged column

Concrete testing was performed (compressive strength and petrographic examination) and nondestructive evaluation (NDE) methods were used to determine the severity of damage and repair approach. NDE methods included ground-penetrating radar (GPR) survey, ultrasonic pulse velocity (UPV) testing, and pulse-echo scanning (Fig. 5).

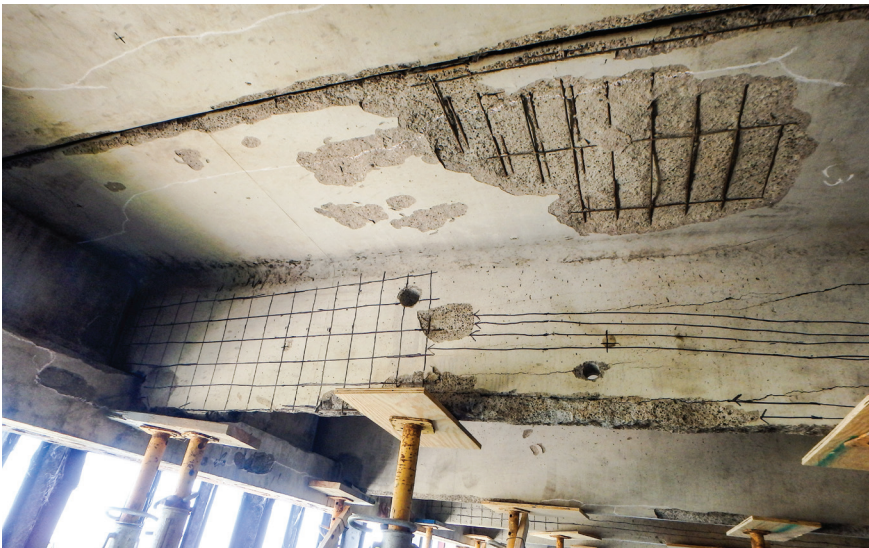
Fig. 6—Concrete cracking and spalling due to fire

The visual reviews and delamination survey indicated that fire-related distress had occurred in the form of concrete cracking and spalling, including delaminations identified in several crucial structural beams and columns (Fig. 6). The concrete distress was more severe at members near the expansion joint. Core compressive strength testing did not show degradation of compressive strength as a result of the fire event. However, the petrographic examination of the concrete cores indicated the extent of surficial concrete damage as a result of exposure to fire-elevated temperatures was up to a depth of 0.4 in. (10 mm).

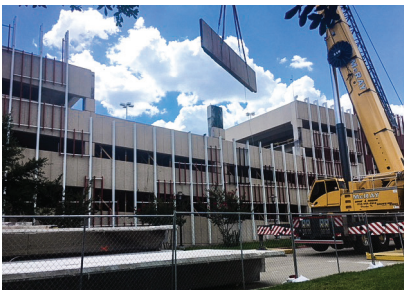
Fig. 7—Spandrel beam replacement

reinstalled in their original position. Two spandrel beams were hoisted down, removed from the site, and replaced with new members (Fig. 7). New replacement double tees were hoisted into place for final repairs (Fig. 8).

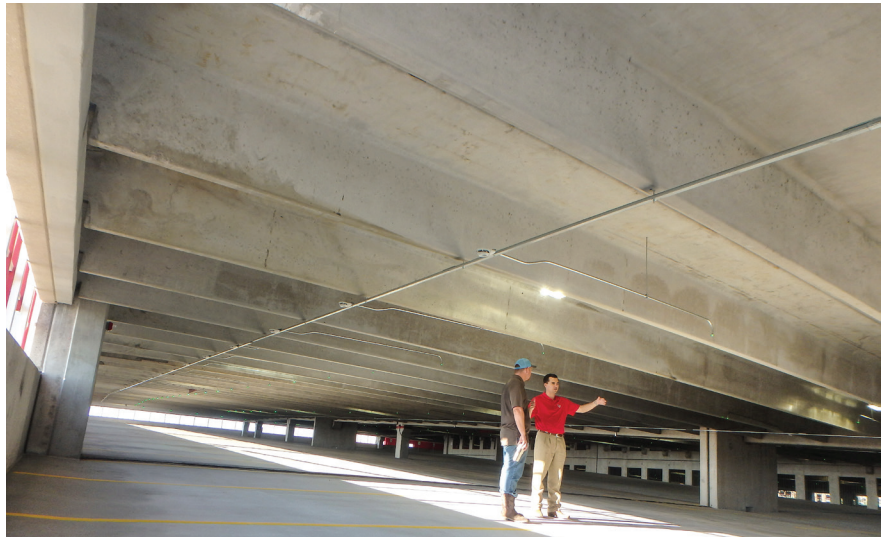
Fig. 8—New replacement double-tee beams at completion

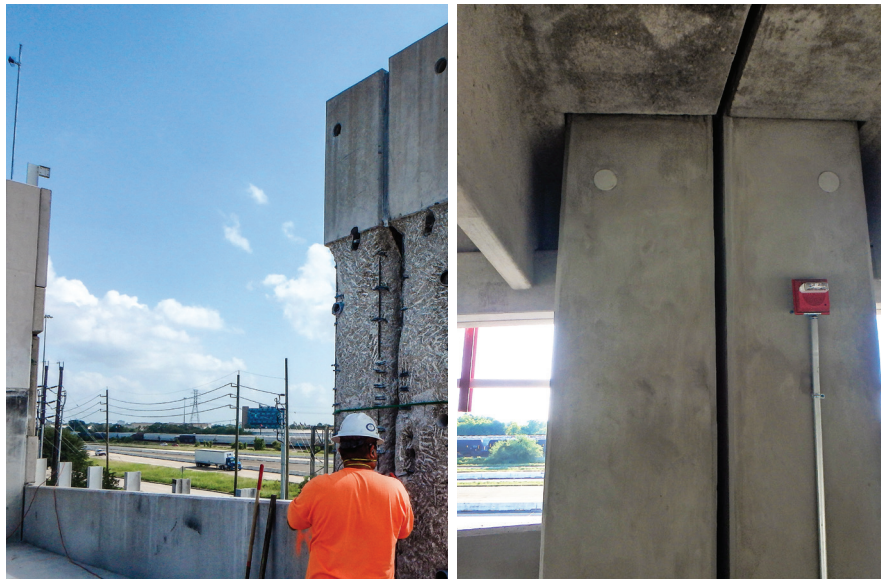
Fig. 9—Column during repair (left) and after repair (right)

Other repair works included the repair of concrete columns supporting Level 4 (Fig. 9), spandrel beams on Levels 3 and 4, double-tee members on Level 4, topping slab replacement on Level 3, and waterproofing installation on Levels 3 and 4. The damaged expansion joint system on Level 3 was replaced and a new expansion joint system was installed on Level 4. Joints were tooled in the topping slab and sealed above the double-tee flange-to-flange joints, and construction joints were routed and sealed. Cove sealant was installed at the perimeter bumper wall and columns.
